THE MARION STEEL COMPANY

PCB SPILL CLEAN UP DOCUMENTATION, Report Amended June 28, 1993

Re: Remediation of PCB spill area.

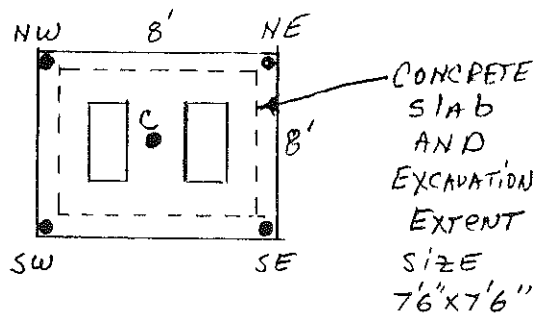
PLANT SUBSTATION AREA

Cousins Environmental Services was contracted to re-establish the area of contamination. The results indicated that there was still spotted saturated soil directly beneath the capacitor bank. (Please see attached Cousins report).

On May 4, 1993, Cousins personnel arrived at the spill site for the specific purpose of collecting samples to quantify the extent of the contamination caused by the spill. This spill occurred underneath a small capacitor bank within the plant substation. The area under the capacitor bank was sectioned off for the purpose of establishing a sampling grid. A schematic of the spill area and the collection points of the samples is attached in Appendix A. Samples were taken at the corners of the four boxes at depth intervals of surface, one foot, and two foot. A sample was taken directly beneath the capacitor bank at the depth of one foot. The capacitor bank supports are resting on a concrete slab at a depth of one foot below the surface. The slab is represented in the schematic as the dotted line.

The second remediation effort was performed by Cousins on June 24, 1993. An area of 7'6" x 7'6" was excavated around the capacitor bank. The depth was approximately 1 foot of soil to a slab or footer of concrete which is in place to support the capacitor bank. Apparently the information on the initial cleanup depth of 2-3 feet is inaccurate. The clean up generated approximately 6 - 55 gallon drums of soil and a total weight of approximately 2,500 lbs. - Please see attached Cousins report.

The results of the analysis are enclosed in Appendix B. From the results of the analysis the area to be remediated was determined. On June 24, 1993, Cousins personnel returned to the site to complete the remediation. The remediation consisted of excavating the contaminated soils beneath the capacitor bank from the surface to the top of the concrete support slab. The extent of the excavation is shown in the schematic in Appendix A. After the excavation, the slab was inspected for the presence of cracks. This inspection revealed that the slab did not have any cracks, thus there is no reason to believe that the contamination went any further. The excavation generated six drums of PCB contaminated waste which were properly labeled and staged for disposal. The maintenance staff at the site provided the clean backfill for the excavation.
